LENZ PEST CONTROL

WOOD DESTROYING PESTS AND ORGANISMS INSPECTION REPORT

Building No.	Street, City, Zip	Date of Inspection	No. of Pages
3354	Cliff Dr. (main), Santa Barbara, CA, 93109	09/24/09	5

Firm Registration No. PR 2594	Report No. 14295A	Escrow No.
Ordered By: Sotheby's Realty 1436 State St. Santa Barbara CA 93101 Michael Calcagno 963-1391 896-0876	Property Owner/Party of Interest: Thomsen % Sotheby's 1436 State St. Santa Barbara CA 93101 Michael Calcagno	Report Sent To:

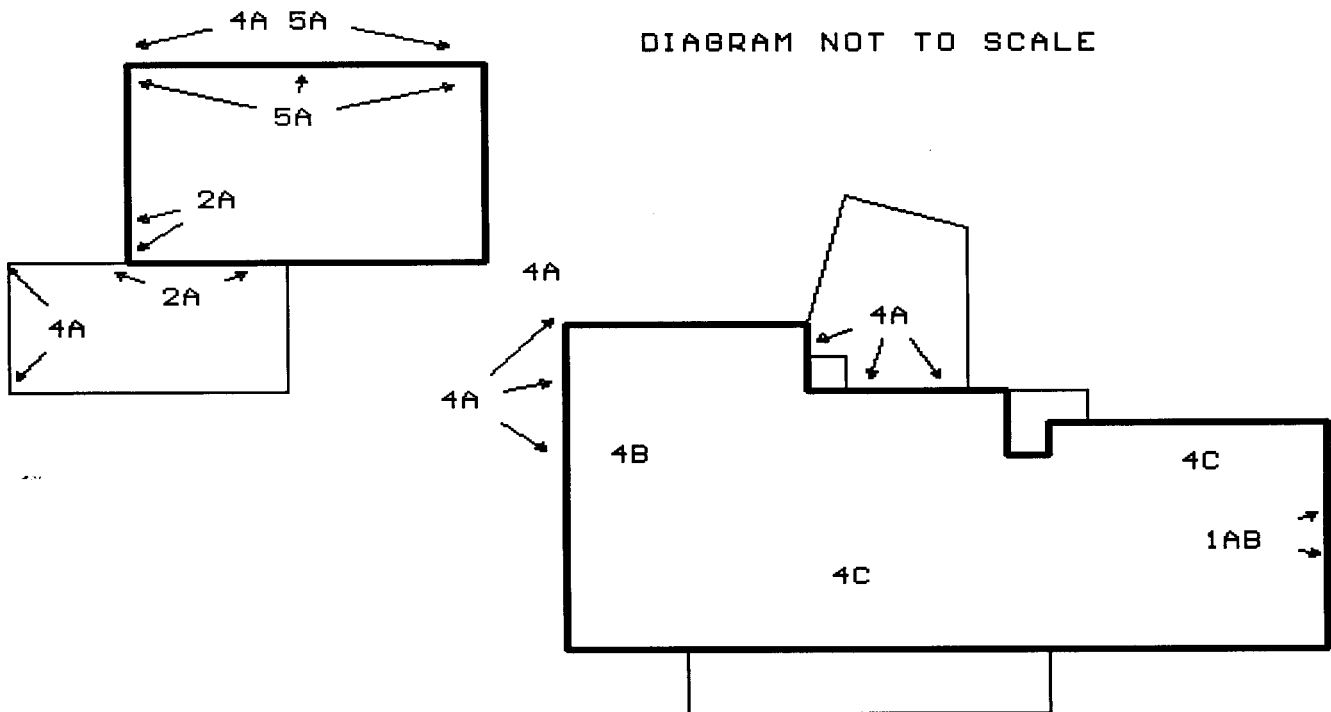
FRONT

Item 1A: Finding: Evidence of subterranean termites found at the wall area entering through cold joints as indicated on the diagram by 1A.

Item 1B: Finding: Subterranean termite damage found at the window sill and frame as indicated on the diagram by 1B.

Item 2A: Finding: Evidence of drywood termites found in the garage as indicated on the diagram by 2A. Infestations appear to extend into inaccessible areas.
Recommendation: Vacate and seal the structure. Fumigate with Vikane (Sulfuryl Fluoride) and Chloropicrin (warning agent) for the extermination of drywood termites. Remove seal, air out the building, ready for occupancy. When possible, remove or cover accessible evidence. This company will not be liable for possible damage to plants, paint, roofs, T.V. antennas; reasonable care will be exercised. Fumigation cannot take place in strong winds or rain and will be rescheduled if there is inclement weather.

Item 4A: Finding: Earth-wood contacts found at the siding bottom as indicated on the diagram by 4A.

Item 4B: Finding: Moisture stains found at the shower bathroom as indicated on the diagram by 4B.

Item 4C: Finding: Moisture stains found at the ceiling as indicated on the diagram by 4C.

Item 5A: Finding: Wall area was inaccessible for inspection due to storage as indicated on the diagram by 5A.

Recommendation: Drill holes through concrete about 1' to 2' apart, treat the earth fill with Premise (Imidacloprid) for the control of subterranean termites and seal drilled holes. This company will not be liable for possible damage to hidden pipes, conduits or ducts in or under concrete slab. Local treatment is not intended to be an entire structure treatment method. If infestations of wood-destroying pests extend or exist beyond the area(s) of local treatment, they may not be exterminated.

Recommendation: Remove damaged areas and repair with new material and/or wood filler as necessary. Ready for painter.

Recommendation: Eliminate earth-wood contacts as necessary. A supplemental report will be issued if detrimental conditions are found.

Recommendation: Any questions regarding this condition should be referred to a licensed contractor.

Recommendation: Others are to provide access to permit inspection. A supplemental report will be issued outlining findings and additional costs.
